REPAIRING HOLDING TANK CONNECTIONS

Anyone else having, or about to have, holding tank leaks?

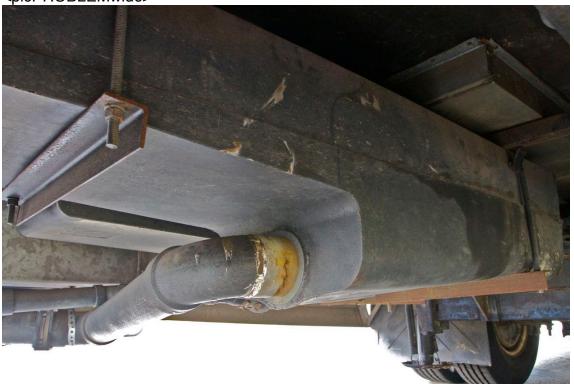
<picPROBLEMwide>

When I first chased down my first few dreaded drips on the pavement I remember actually thinking "...simple maybe a stronger clamp would do". Once I looked closer I realized the connection collar was disintegrating due to stress cracks. The cracks ran not only on the collar parallel to the piping but also into the base part that welds into the tank body. Stress fractures due to improper mounting, UGH! More on that in a bit.

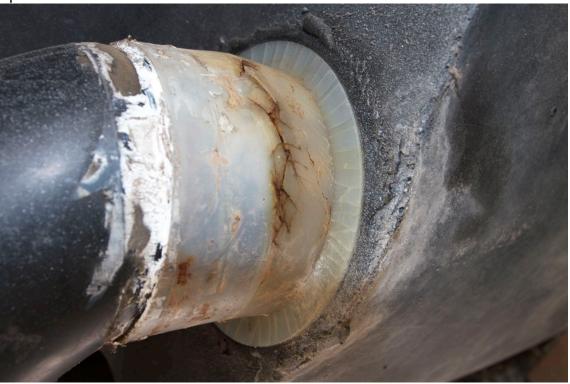
<picPROBLEMclose>

Without it and just jamming the hard ABS pipe into the hard PET tank collars (at least on Isuzu Treks, probably all models) you can expect even gentle road bumps to act as a LEVER at the end of some 4+ feet of pipe wrenching and eventually destroying your tanks' PET collars.

Off the shelf at any Home Depot, Lowe's, ACE, etc. plumbing aisle for about \$4 will be a "soft union collar". A simple rubber collar to go between the dump manifold pipe and hard tank collar, in sizes common for both gray and black tanks. They even come with the stainless pipe clamps needed.

This soft union will absorb the really hard twists and bumps. Yes, you will have to replace them every few years when the rubber starts to crack but this is a MUCH kinder and less expensive than catastrophic Black Water tank failure at 50 mph or worse at a stoplight...in front of a police officer!

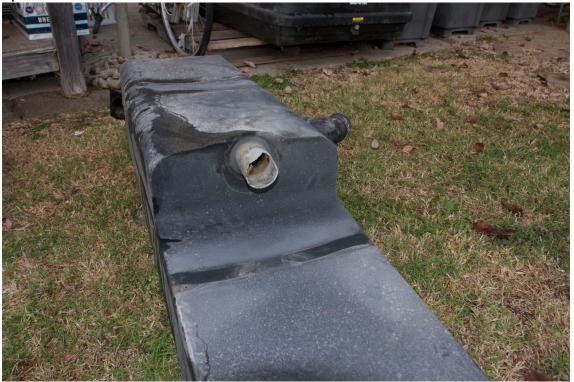
<picOUT&PREPPED>

After a quick look and deciding my original ABS tanks were in great shape but the PET (white-ish) attachment collars were toast. He called over one of his production line guys and told him to help me out...30 minutes later... I had two tanks with brand new collars stronger than the original!

I promised to pressure wash and bleach scrub them thoroughly and he told me to drive them up to his production plant, about 3hrs north of LA, on a slow day and he'd see what he could do.

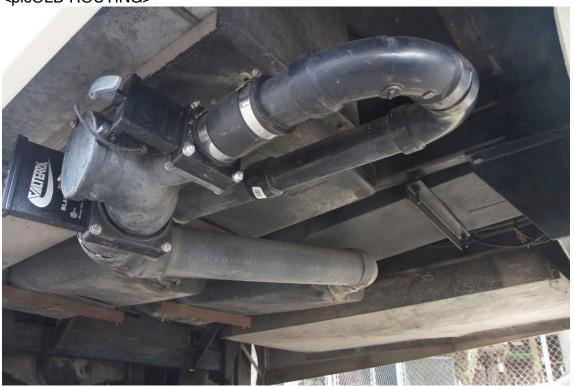
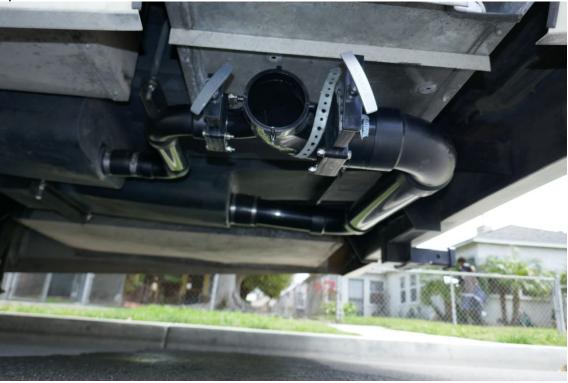
<picOLD ROUTING>

With the tanks reinstalled I couldn't resist to re-plumb the whole dump manifold and get rid of some real silly contorsions of pipe routing. I gained another 2 inches or more of ground clearance back there!
