Installation Instructions #214

IMGL* and 9510 Control Replacement Kits *Integrated Motor/Gear Box/Linkage

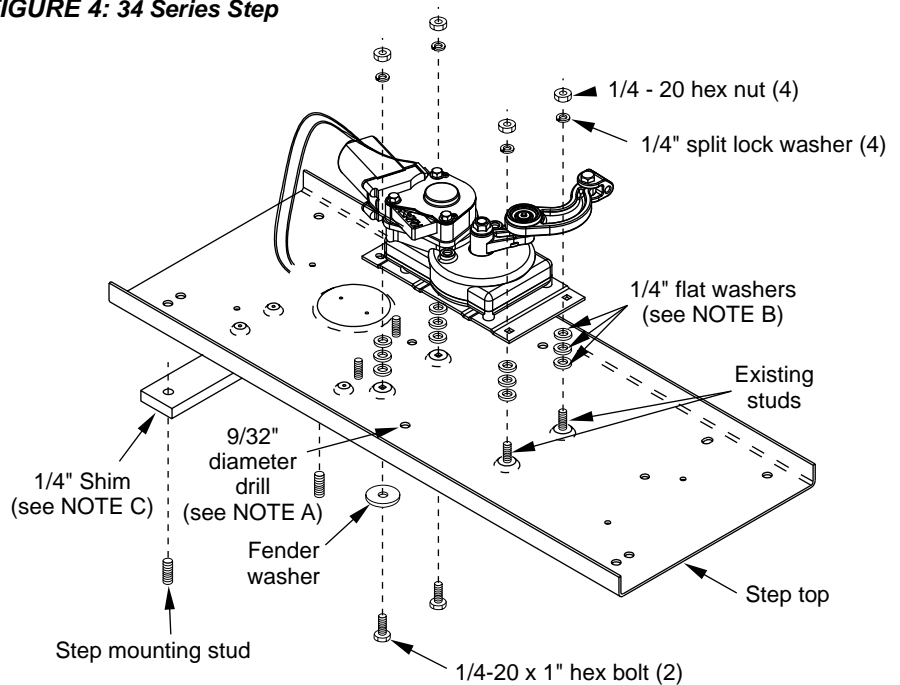
FIGURE 4: 34 Series Step

See **Figure 4** for important information on remounting 34 Series steps flush against the step mounting surface.

NOTE C: If the step was originally installed flush against the step well, a 1/4" thick shim may be needed (not provided) so the motor assembly mounting bolt heads will clear the mounting surface.

NOTE: On 23 and 34 Series steps, see the mounting instruction, Figure 3 and 4, when replacing a #8287 double reduction motor with a permanent magnet motor assembly.

1. If the step frame is mounted flush against the step mounting surface, the step will have to be removed to access the top side of the step frame.
2. The hole pattern for the new IMGL assembly does not line up properly with the old mounting holes. See **Figure 3** for a mounting diagram for the 23 Series Step and **Figure 4** for the 34 Series Step.
